Bridge Deck Protection

OTHER BRIDGE COMPONENTS

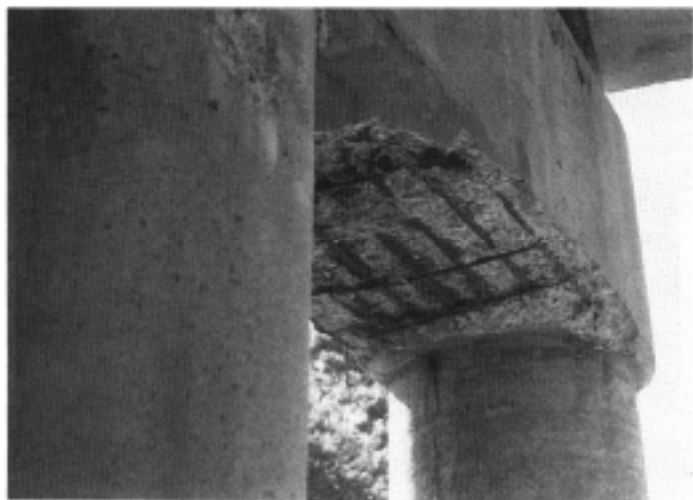
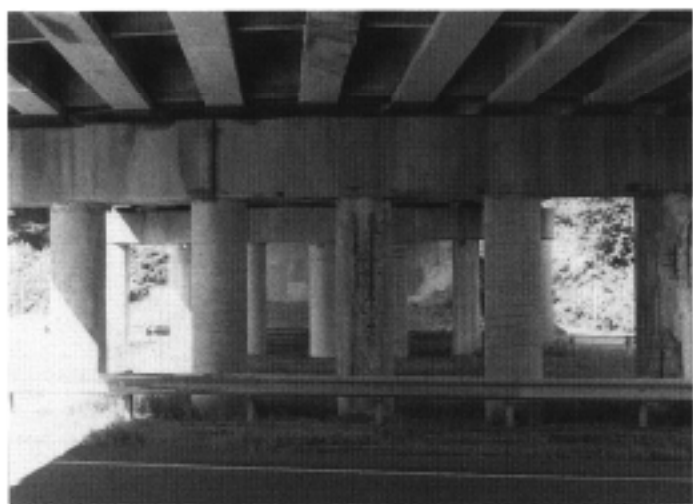
FIGURE 3-6 Concrete spalling on bridge structure.

Road salt is frequently associated with deterioration of bridge structural elements made of reinforced concrete (AASHTO 1976, 61–66). The problem is similar to that of concrete decks; chlorides from road salt, along with moisture, migrate to the rebars, inducing corrosion and causing the surrounding concrete to crack (Figure 3-6). Reinforced concrete box beams, stringers, pile caps, and support columns are among the structural elements affected. Leaky joints, poor drainage, and splash and spray from traffic provide avenues for salt access.

Because road salt is not applied directly to these elements, salt damage takes longer to be identified and is generally not as extensive as salt-induced damage to decks. However, because of cramped working conditions and the need for falsework and scaffolding, repair of even minor damage can be difficult and expensive. Research is under way to develop less costly repair and rehabilitation treatments, such as electrochemical chloride removal (Broomfield and Jawed 1990; Manning and Schell 1987; Manning and Pianca 1991). These treatments, along with greater attention to deck drainage and corrosion protection (such as epoxy-coated steel) should help reduce the severity and incidence of this damage. Nevertheless, because rehabilitation of the structural components of one long-span bridge can cost several million dollars (personal communication, Structure Division, New York State Department of Transportation), the total cost of salt-related damage is likely to be quite high.
